## Flooding & Drainage - around Lye Green & Chesham

A brief review of the long-known flooding and drainage issues around Chesham

## Reducing flooding in Chesham Newsletter Summer 2018

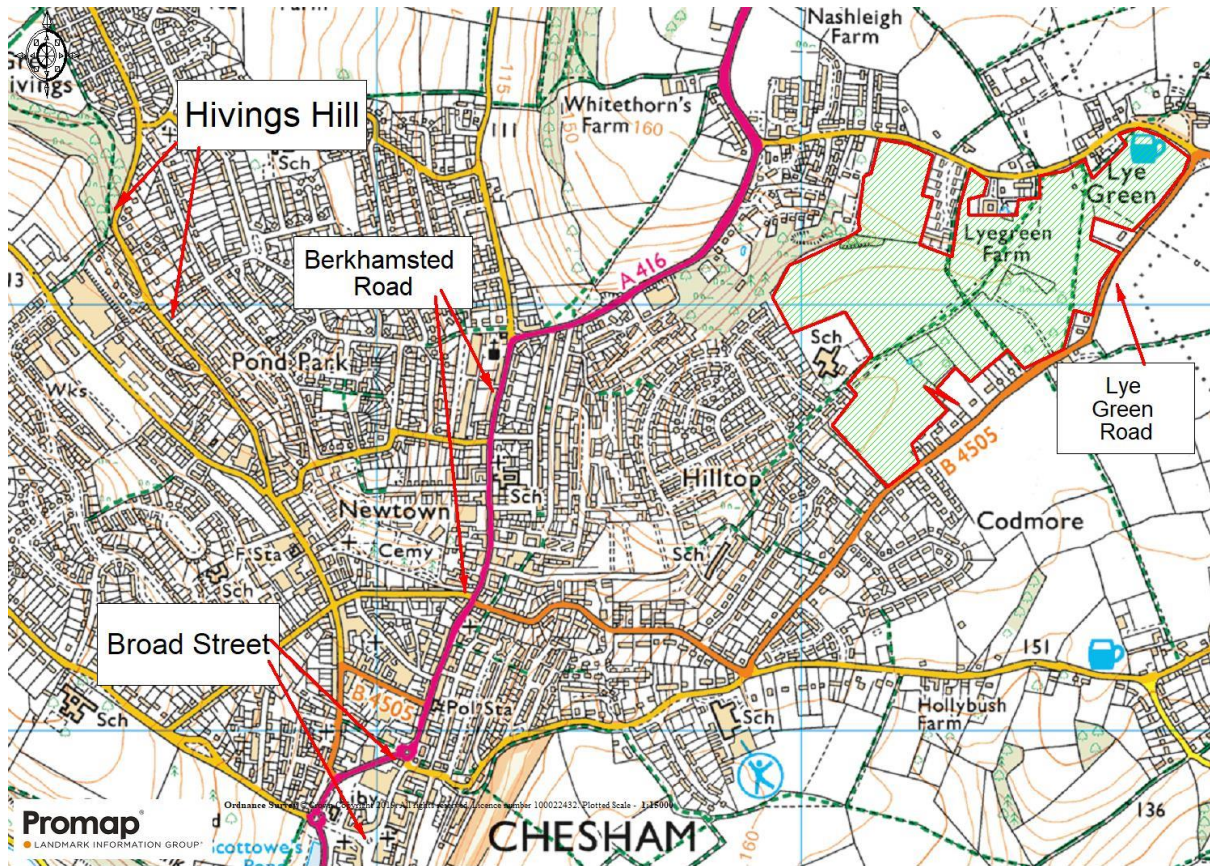
- The above OS Plan shows the locations of some of the local regular flooding points around Chesham – Broad Street & Berkhamsted Road are low points in the valley floor but Lye Green & Hivings Hill are relatively higher either on the valley sides upon a settled plateau overlooking the town.
- The following pictures taken in 2014 are of the roads beside the Lye Green site which were closed for several days due to prolonged rainfall and the runoff of water from the fields onto Lye Green road.

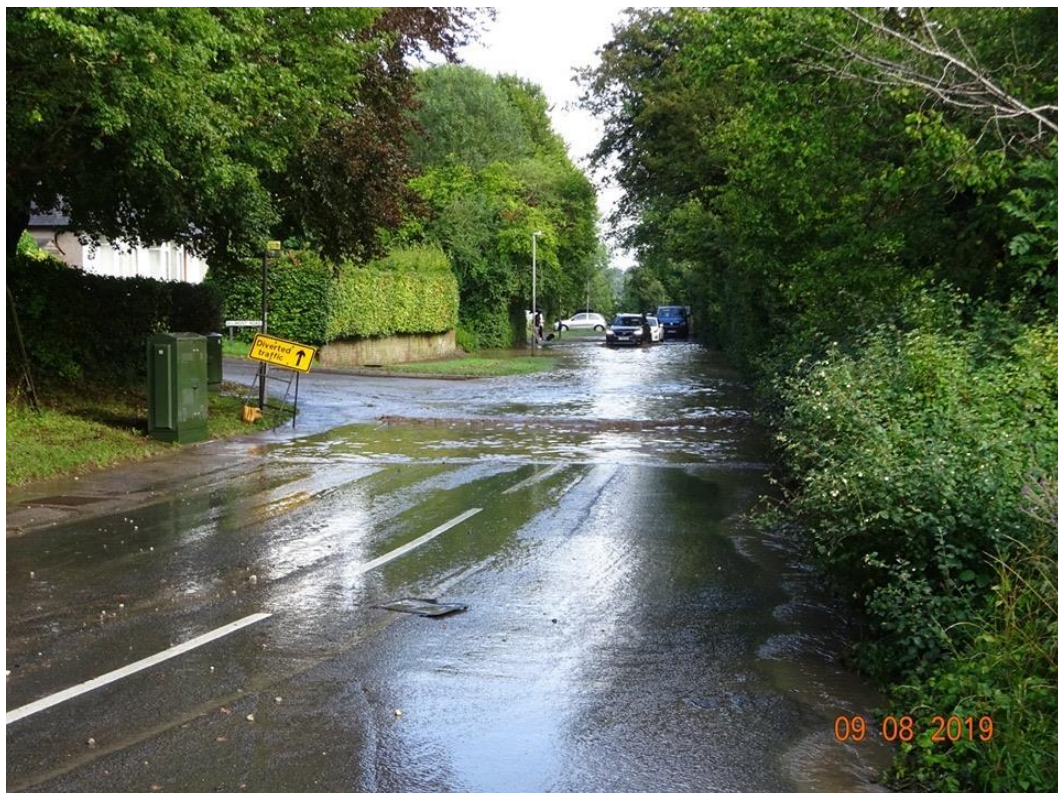
Flooding on Hivings Hill - August 2019

- Self-evidently, the build-up of surface water on such relatively high ground does eventually also add to the problems of surface water flooding in the lower areas of the town itself in due course too. This is mainly seen in Broad Street & Bekhamsted Road and in side roads leading off both roads but as the following picture shows also occurs in Hivings Hill and other areas of the town.

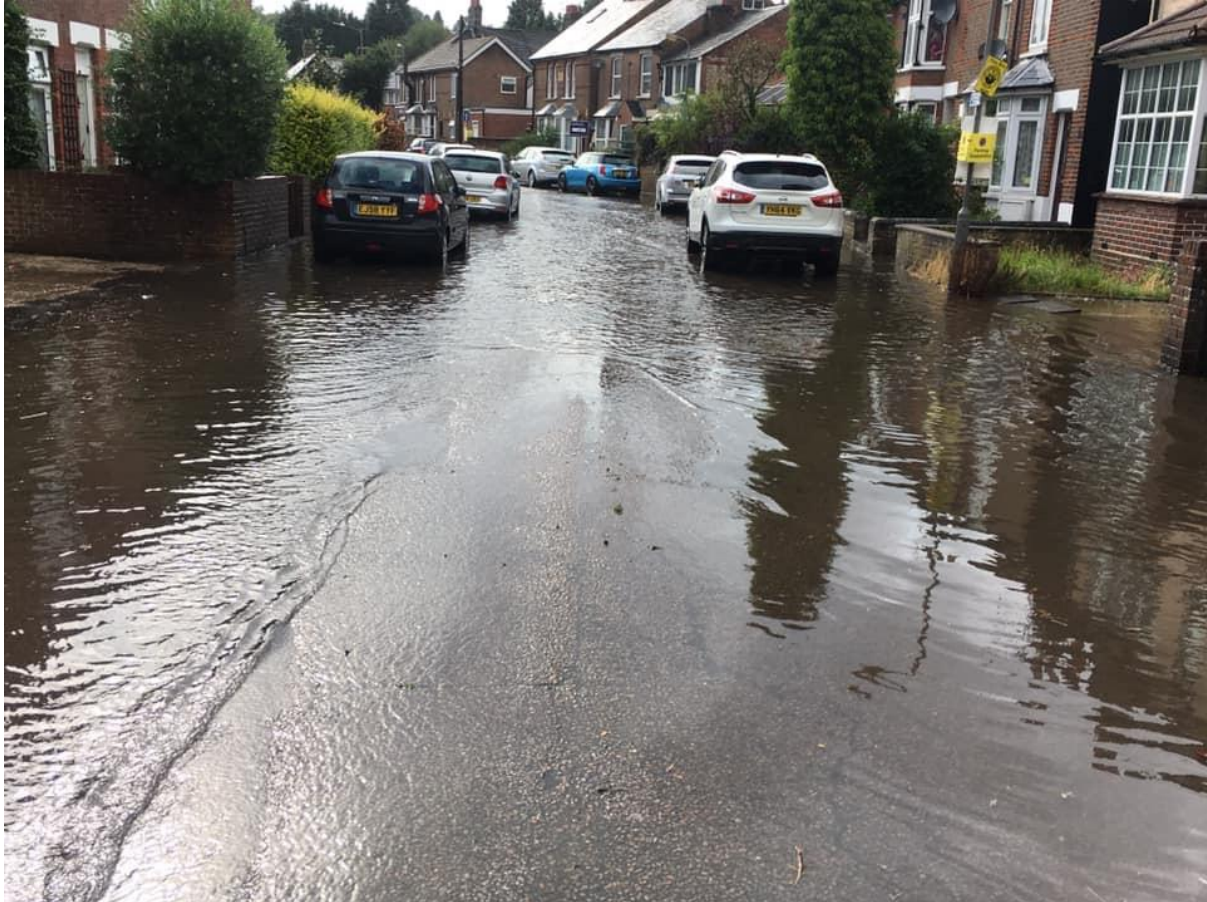
The flooding is caused by:

- high groundwater levels combined with rainfall
- surface water flooding, especially in steep areas during heavy rainfall
- river flooding from the River Chess and Vale Brook

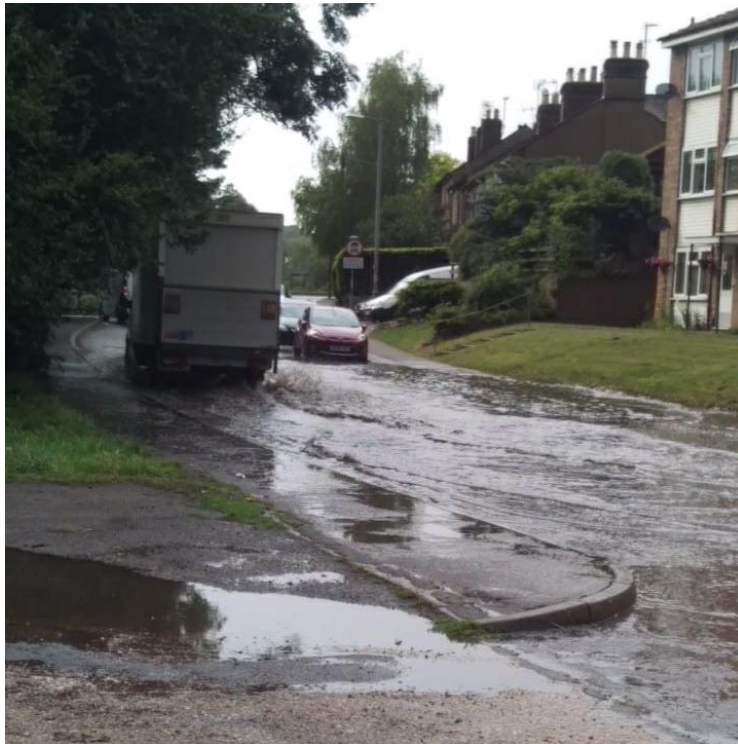
- The aged drainage system of the town clearly cannot cope with prevailing needs of the town and any significant development upon Green Belt on high ground outside the town has obvious potential to make matters worse.
- FloodSmart was a project that ran from 2013 to 2015. The aim was to enable Chesham to be more aware, resilient, and prepared for the effects of flooding.
- It was part funded by the Department for Environment, Food and Rural Affairs, (Defra) and managed by Buckinghamshire County Council, working in partnership with the Environment Agency, Chiltern District Council, Chesham Town Council, and the National Flood Forum.
- Although certain works have been done, as can be seen from some of the more recent pictures attached herein, taken just in 2019, the problems still persist.

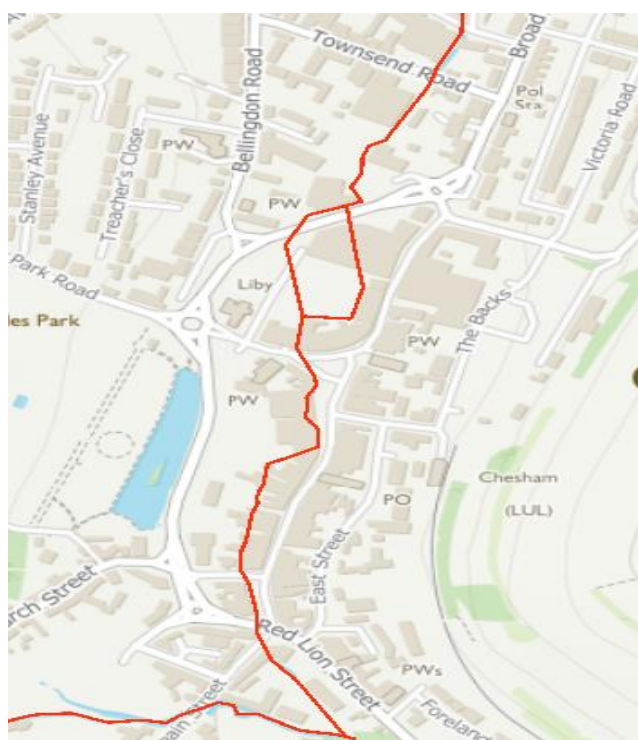
*Current route of the Vale Brook*

The Vale Brook runs through the centre of Chesham. This brook is largely underground in a series of buried tunnels (called culverts). Some of the culvert sections are now over 150 years old and they are in varying states of disrepair. The debris within the culvert limits the amount of water that can flow through it, causing a flood risk during heavy rain.

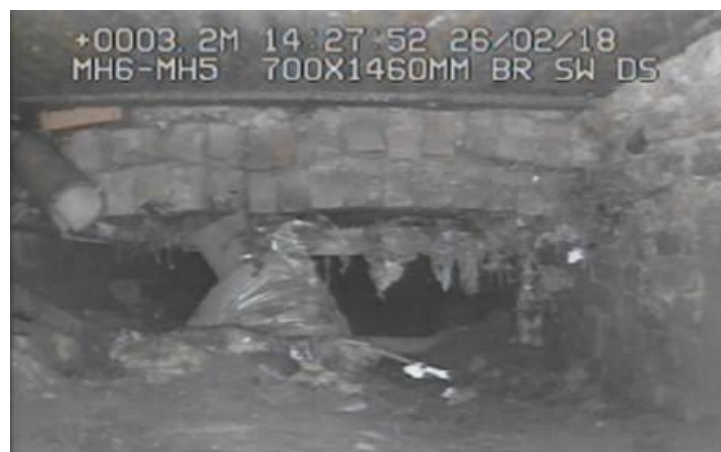
The survey confirmed which sections of the culvert are in poor condition and where debris has built up. The CCTV remote vehicle used to enter the culvert was unable to enter sections through the town centre due to excessive debris. We are working with our contractor to develop a plan to remove some of the debris from the culvert to allow the camera vehicle to pass through. This is a difficult process because of the small size of the culvert and potentially poor condition of the culvert structure.

*CCTV image of the Vale Brook Culvert*

Earlier this year, we commissioned another CCTV survey of the whole length of culvert, from Townsend Road down to where it joins the River Chess. This survey lets us see the latest condition of the culvert to assist our decision making to develop options to reduce short and long term flood risk.

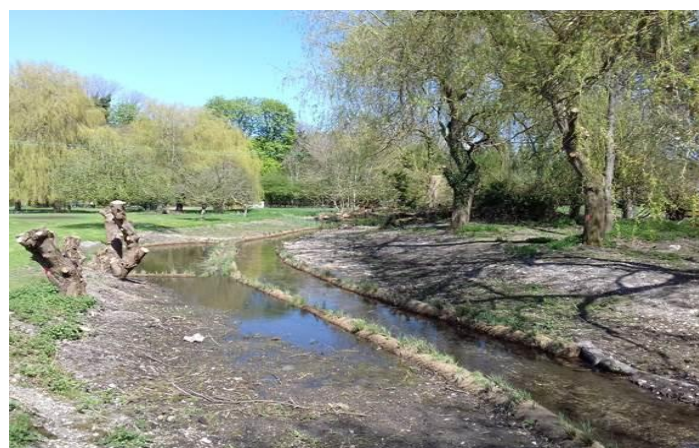
The restored reach is located along a 200m section of the Missenden Stream which flows through part of the Great Hundridge Manor Estate, bordering Chesham Tennis Club and the grounds of the Tennis Club itself. Historically, the river channel in this location has been widened, deepened and impounded by two concrete weirs. As a consequence, flow, when present, is sluggish and the reach acts as a sink for sediment, which overlies much of the gravel bed especially on the upstream side of the weirs and adjacent to the tennis courts, where the channel is at its widest.

By carrying out this restoration work, this section of the river Chess catchment will be returned to a more "natural" state. It will allow the natural chalk stream processes to re-create habitat, carry natural amounts of sediment and reconnect the channel and floodplain. Once the habitat is created the wildlife will come back to this reach of the river Chess.

*Missenden Stream ready to be recolonized by wildlife*
